SITE: PIONEER SAND  
BREAK: 8.6  
OTHER: Vol. 2

Subj: Finalization of Second Five Year Review  
Pioneer Sand Company  
EPA I.D. Number: FLD 056 116 965

November 2004

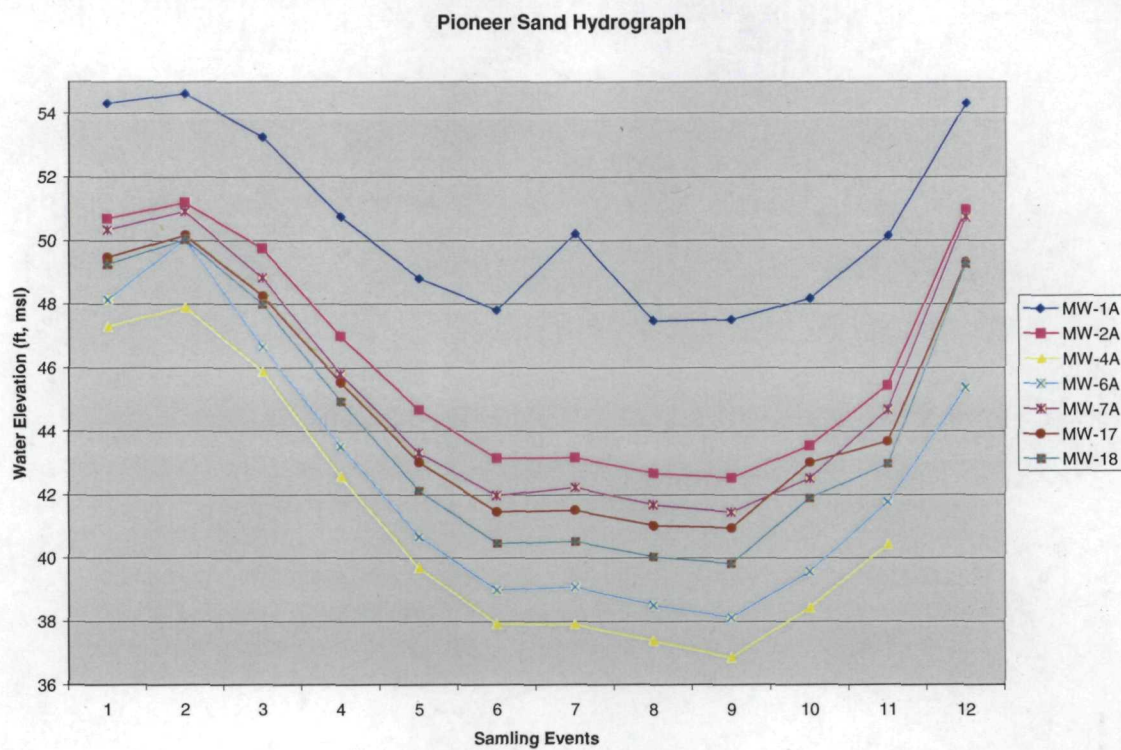
Figure 1 - Hydrograph

<sup>1</sup> CSES recommended that MW-2A be removed from the monitoring plan. In response, EPA generated a hydrograph from the groundwater elevations collected from all of the monitoring wells. Twelve groundwater monitoring elevations were reviewed (see Figure 1). No flow reversals were measured at MW-2A; therefore, EPA is amenable to removal of MW-2A from the monitoring plan.

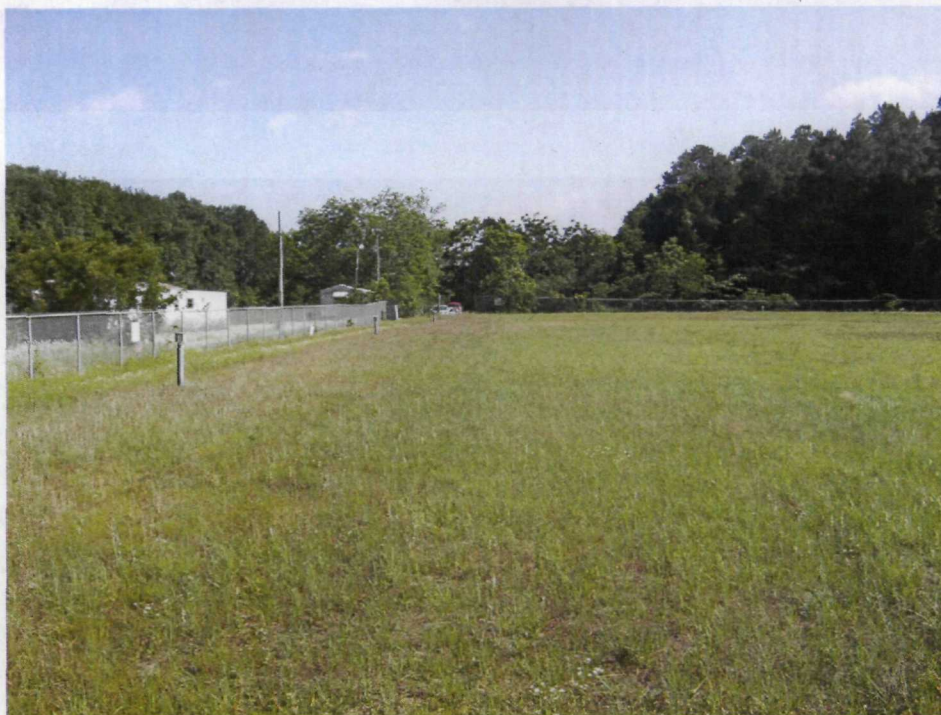
Photograph 1. View looking north across landfill cap taken about 40 feet of west fence. Note 4-inch gas riser pipes along inside of fence. May 20, 2004

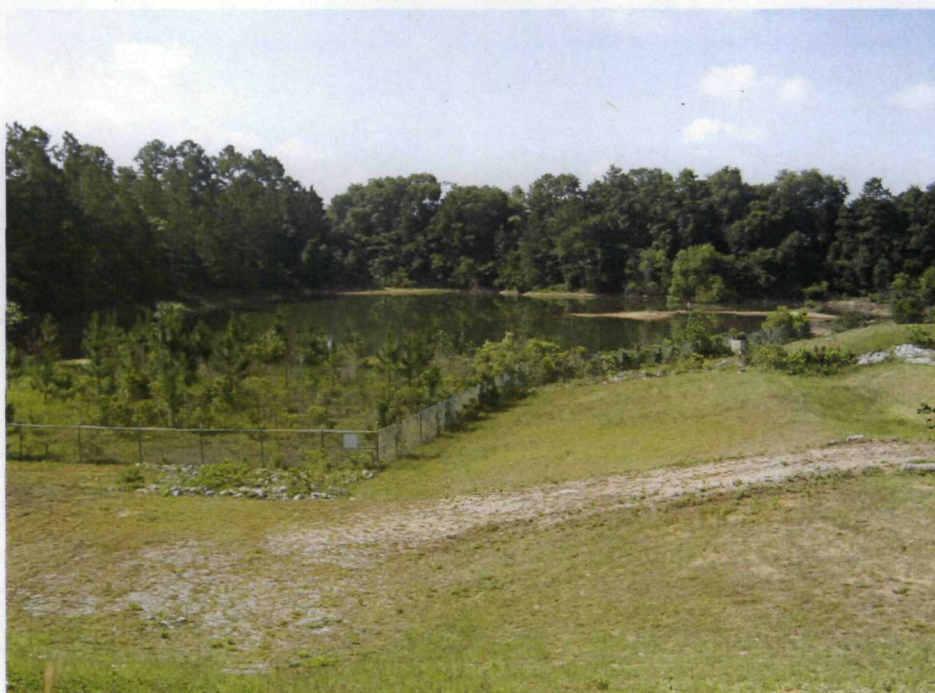
Photograph 2. View looking south from about 75 feet south of the perimeter fence. May 20, 2004

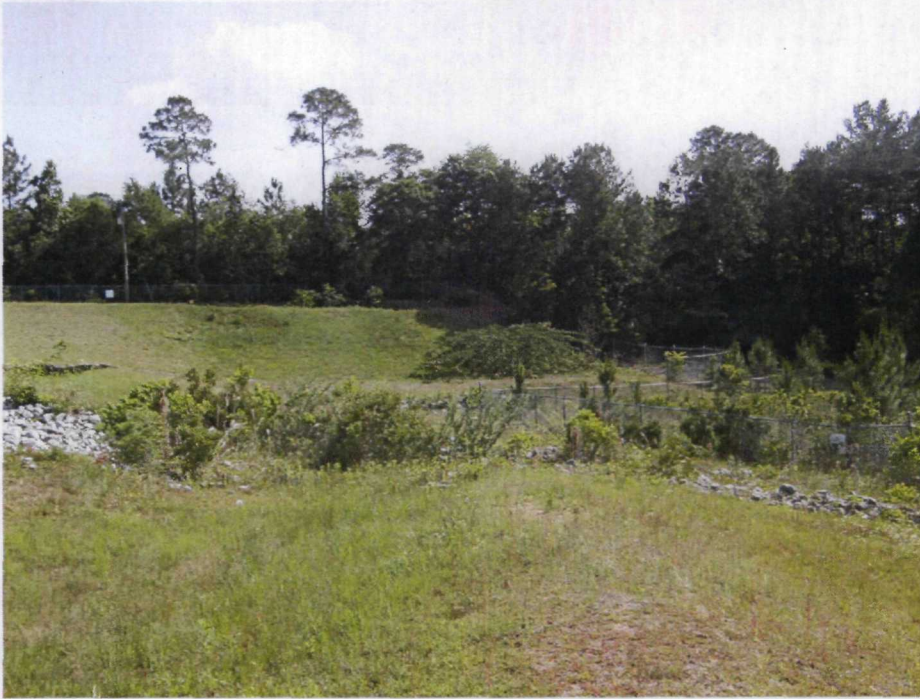
Photograph 3. View looking northeast across cap taken about 40 feet of west fence. Note vegetation growing in the rip rap flume in center of photo. May 20, 2004

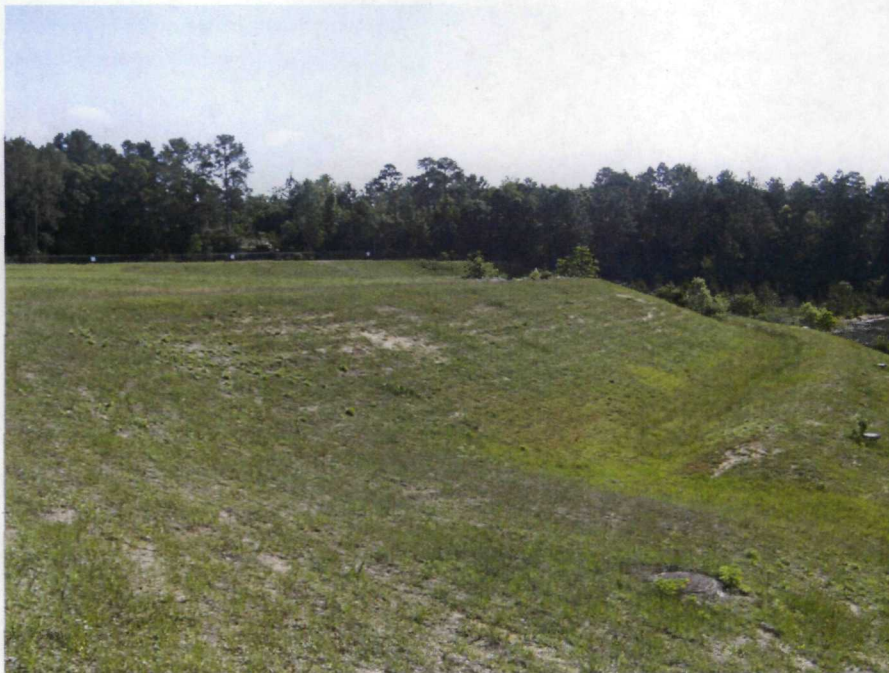
Treatment of leachate has not been needed since leachate has never been collected by the system. The two manholes and the six sampling ports in the leachate collection system were observed and one sampling port was inspected. No deficiencies were noted.

Photograph 4. East-northeast view across landfill cap looking across location of leachate collection trench. Manhole can be seen in foreground and two of six risers are visible in the distance on the right side of photo. May 20, 2004

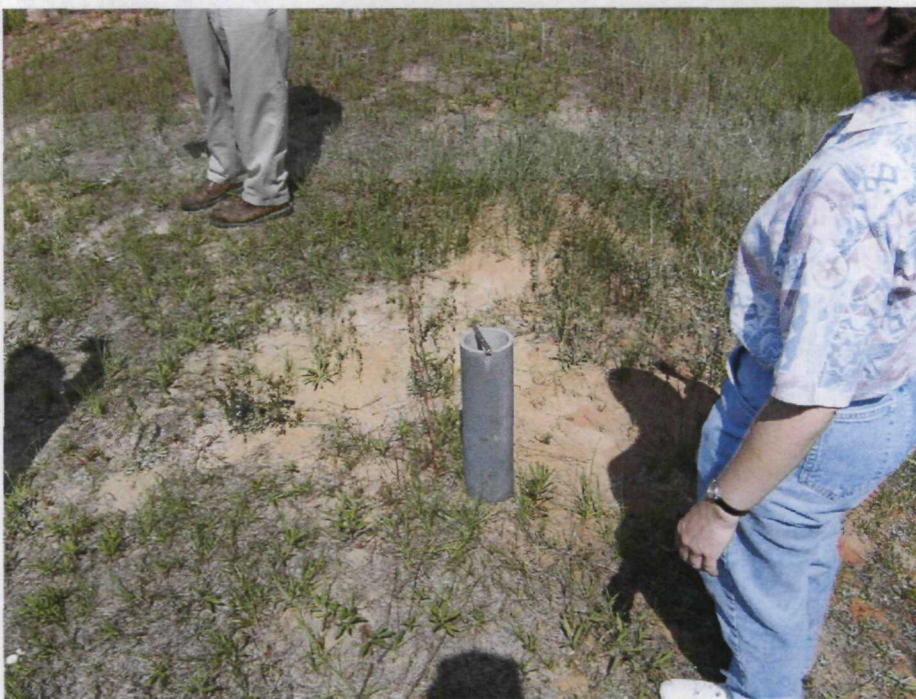
The gas collection and venting system consists of thirteen, 4-inch diameter schedule 80 PVC pipes spaced on 75-foot centers and are located along the western and northern site boundaries. The vents extend from about 18-inches above ground surface to below the landfill cover four feet into a gravel filled trench that intercepts the top of the fill material along the site boundaries. The vent pipes were inspected and one pipe had a vent cap missing. The missing vent cap had been noted in the first five year review.

Photograph 5. View of 4-inch gas vent pipe that is missing cap. Located on eastern most end of the north line of gas vent pipes. May 20, 2004

- e. Replace the missing vent cap on the 4-inch PVC gas vent pipe located along the east-west line of gas vents. (This recommendation was noted in the first 5-year review.)

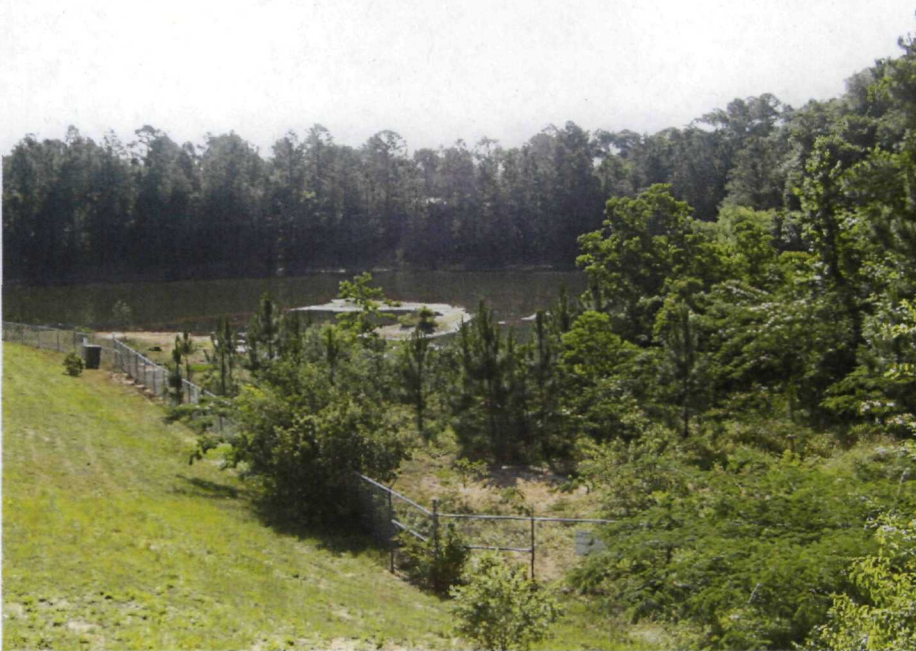
Photograph 6. View looking east from cap toward pond. Monitoring well MW-18 is located in middle left of photo behind small wooden structure beside fence. May 20, 2004

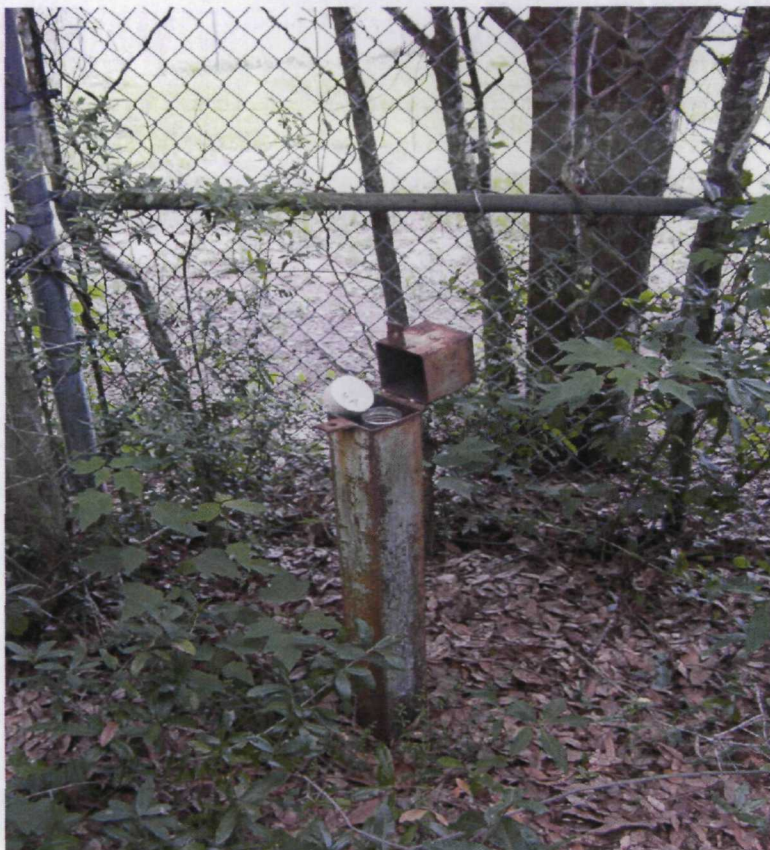
The monitoring wells identified during the site inspection that are part of the groundwater sampling program were MW-1A, MW-2A, MW-4A, MW-6A, MW-7A, MW-17, and MW-18 (see Photographs 7, 10, 14, 15, 16, 18). The condition of the exposed portions of the monitoring wells has degraded over the years (e.g., loss of paint, rust forming). All monitoring wells except MW-2A were secured with a lock. MW-2A was recently damaged by earthmoving equipment working on development of a subdivision east of the site.

Photograph 7. View of monitoring well MW-4A. Protective cover is coated with heavy rust. May 20, 2004

- v. update the O&M Plan to include an assessment of the integrity of wells and protective covers for adverse impacts (e.g., severe rust). If the structural integrity of a well is found to be at risk, then corrective action should be taken.

- i. The protective cover for MW-2A should be replaced and all wells should be properly identified on the well cover.
    - ii. All shallow monitoring wells (i.e., MW-1A, MW-2A, MW-4A, MW-5A, MW-6A, MW-7A, MW-17 and MW-18) should be re-developed.

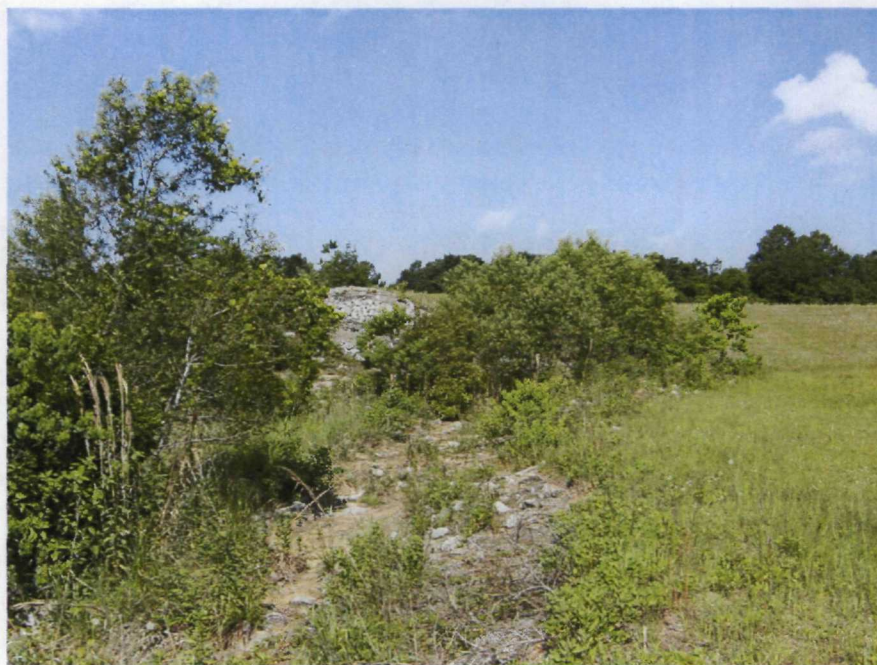
Photograph 8. View looking up flume across landfill cap that is overgrown with vegetation. May 20, 2004

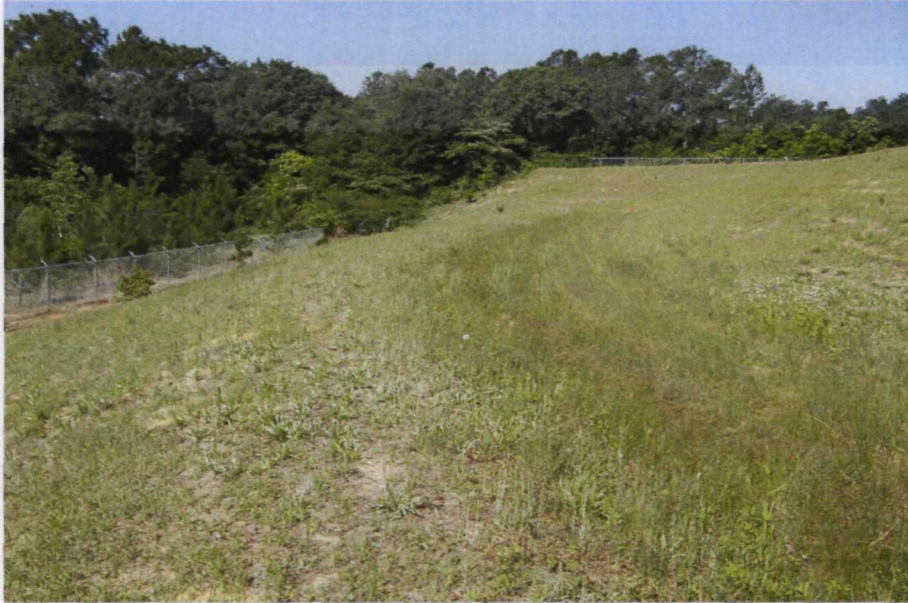
Remarks: Vegetative cover consists predominantly of weeds possibly due to inadequate or improper application of seed and fertilize on the cover.

Photograph 9. View looking southwest from downslope edge of landfill cap shows close-up view of growth on cap that consists predominantly of weeds. May 20, 2004

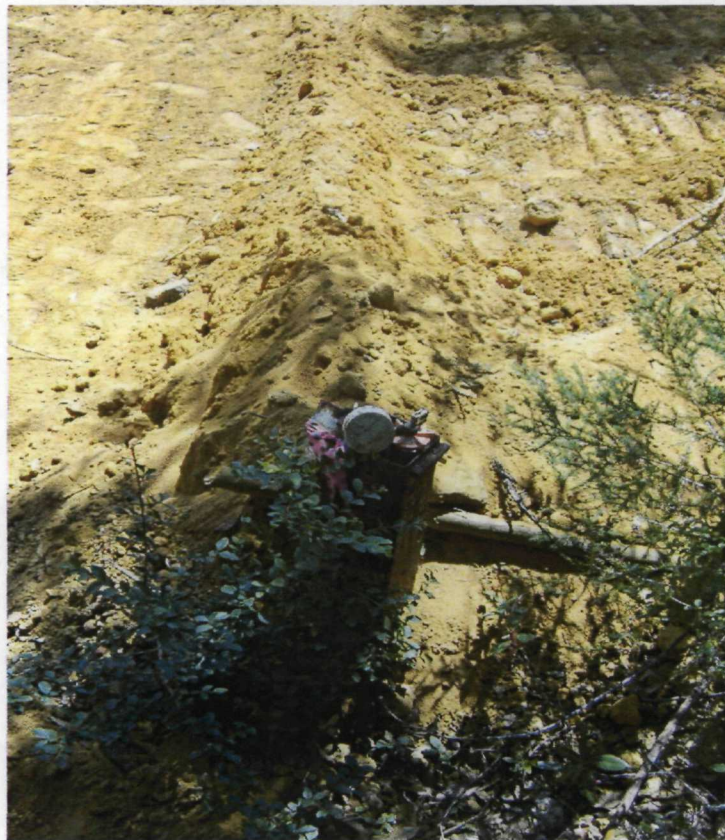
Photograph 10. View of monitoring well MW-2A. Hinge for cap on the well protective casing has been damaged by earthmoving equipment moving dirt at subdivision development. Protective casing has a heavy rust coating. May 20, 2004

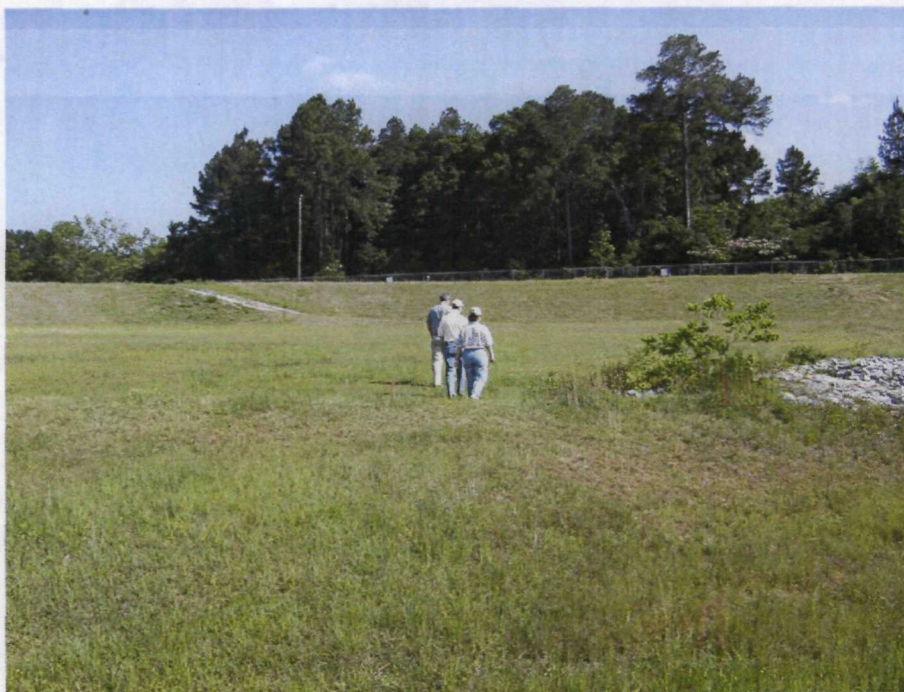
Photograph 11. North view across the landfill cap of vegetative cover. May 20, 2004

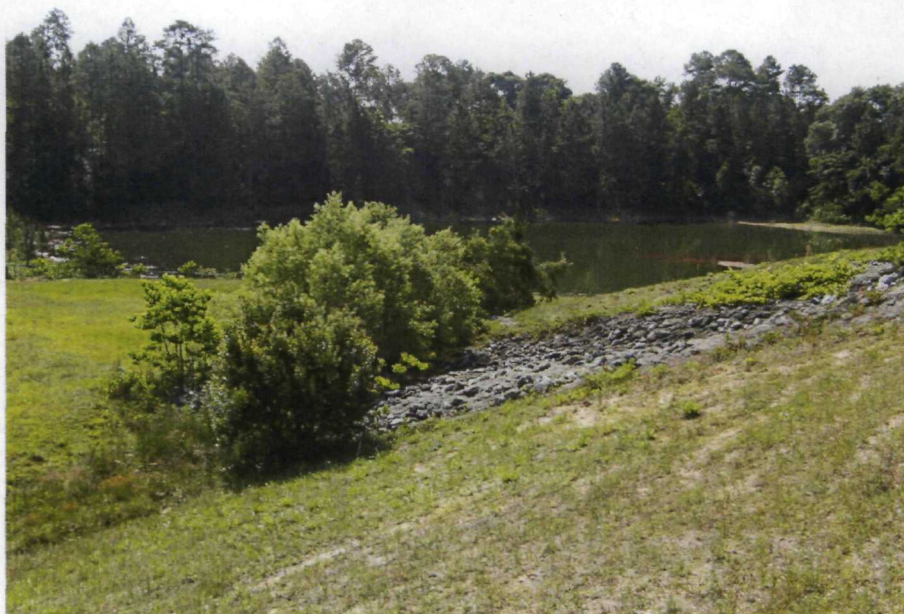
Photograph 12. Southeast view across landfill cover. Note turf consist consists predominantly of weeds with patchy grass. May 20, 2004

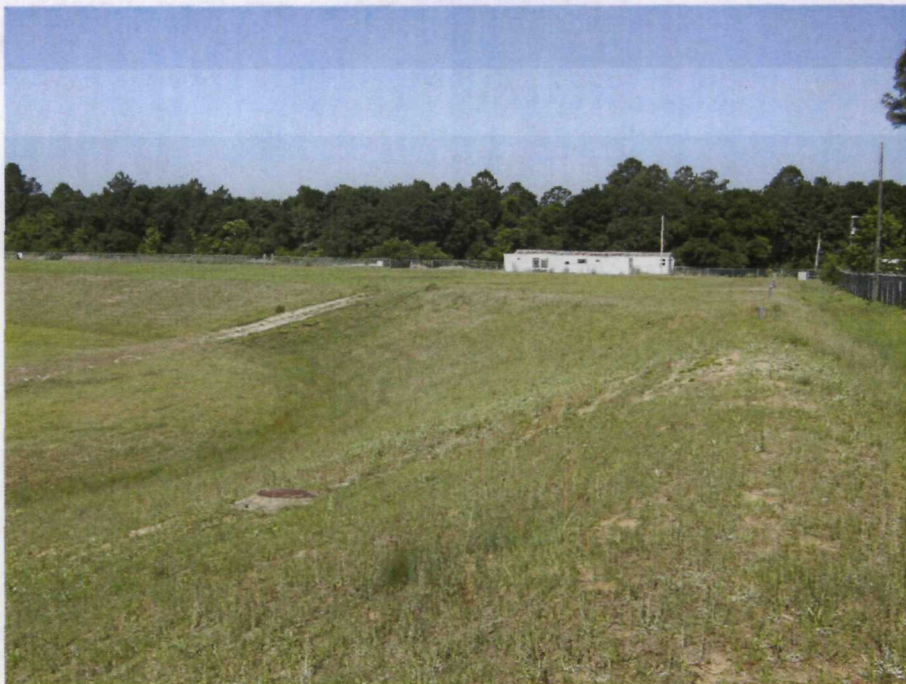
Photograph 13. Southeast view across landfill cover. Note turf consist consists predominantly of weeds with patchy grass. May 20, 2004

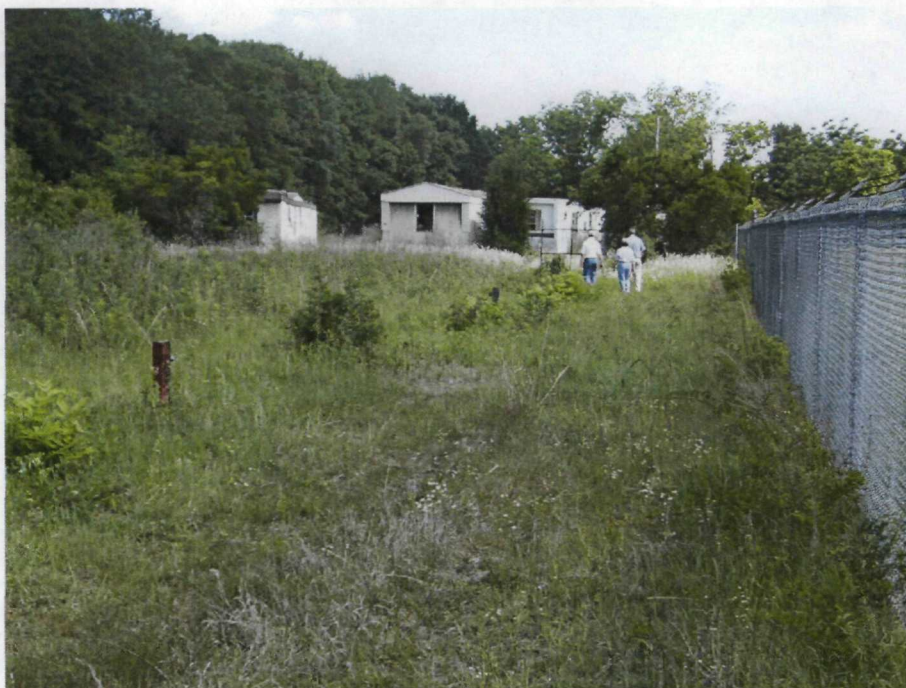
Photograph 14. View looking north along west side of perimeter fence. Monitoring well MW-7A can be seen in the foreground on the left. May 20, 2004

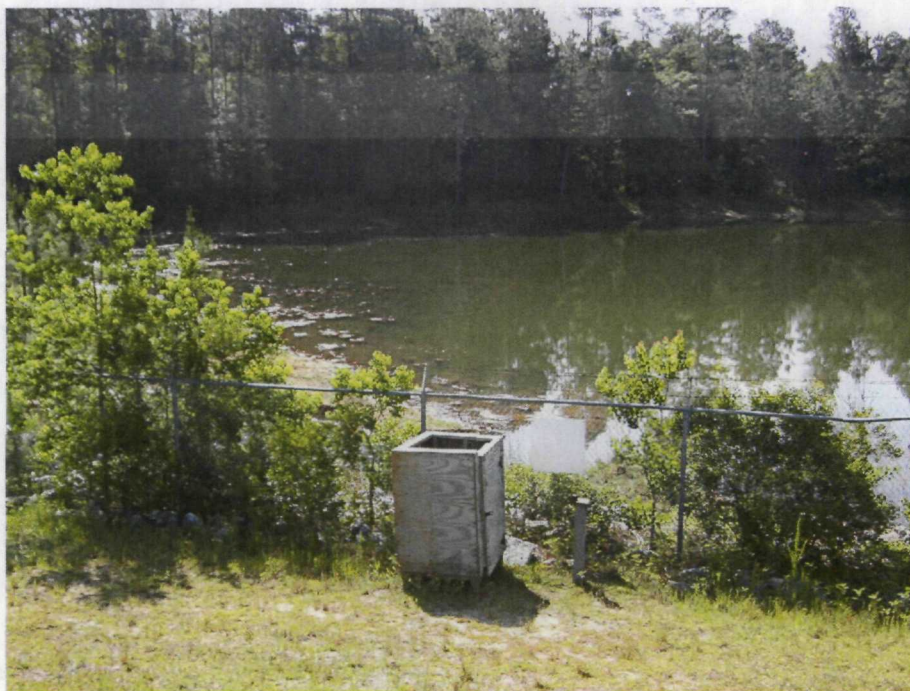
Photograph 15. Southeast view from toe of landfill just beyond the leachate collection trench. Monitoring well MW-17 is located in the foreground. Note well's proximity to pond's edge. Plastic 55-gallon drum is located in the wooden structure beside MW-17. Purge water from sampling MW-17 is poured in to the plastic drum.

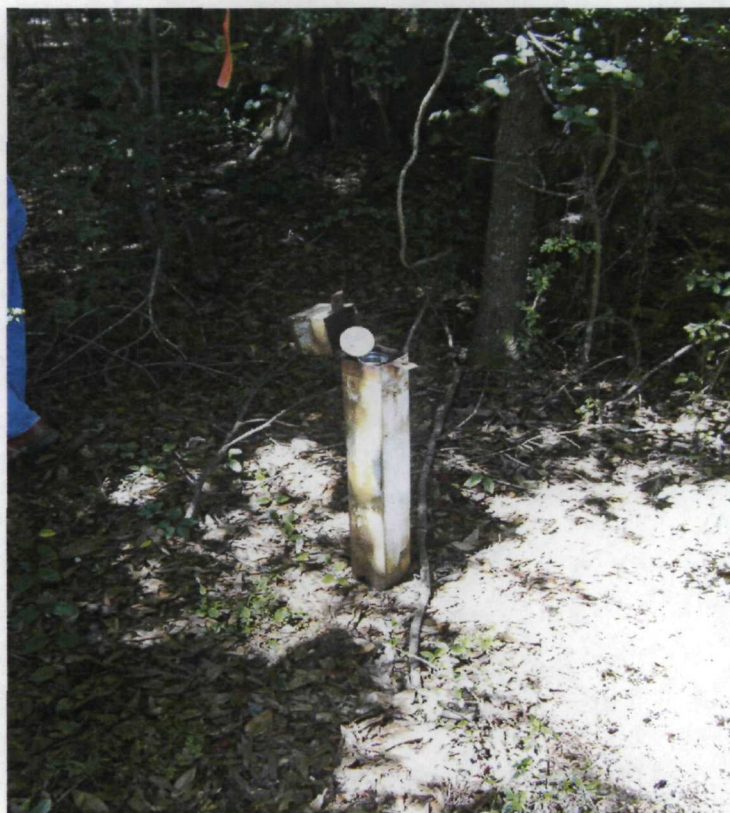
Photograph 16. View of monitoring well MW-6A located on southwest corner of the Site. Protective well casing has rusted through at base. May 20, 2004

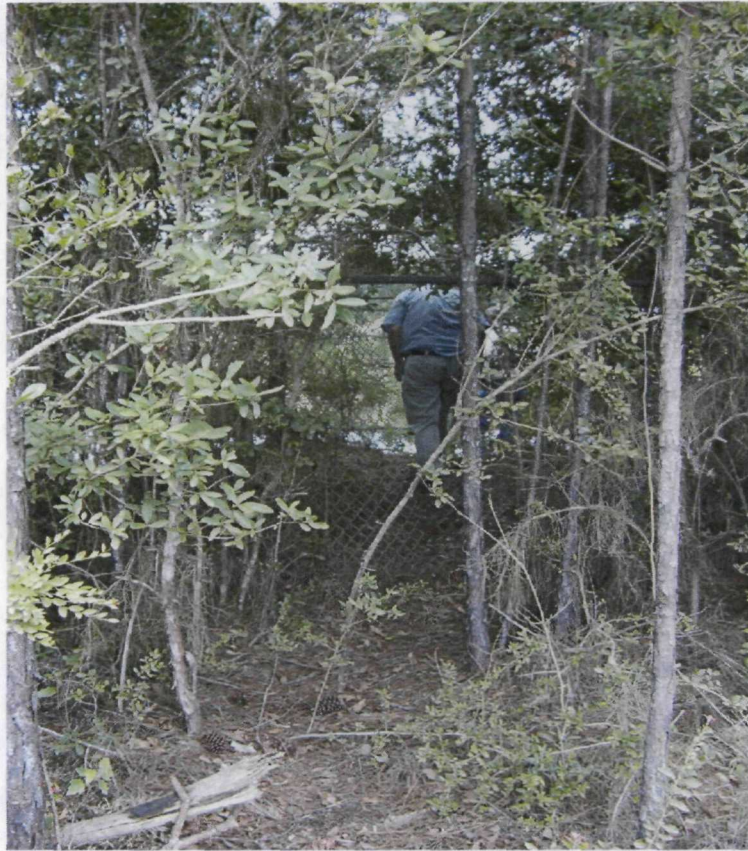
Photograph 17. View of perimeter fence on east side that has been cut by trespassers. May 20, 2004

- f. Check the security of the inner perimeter fence at least semi-annually when the monitoring wells are sampled. The fence conditions should be noted in the O&M semi-annual monitoring report.

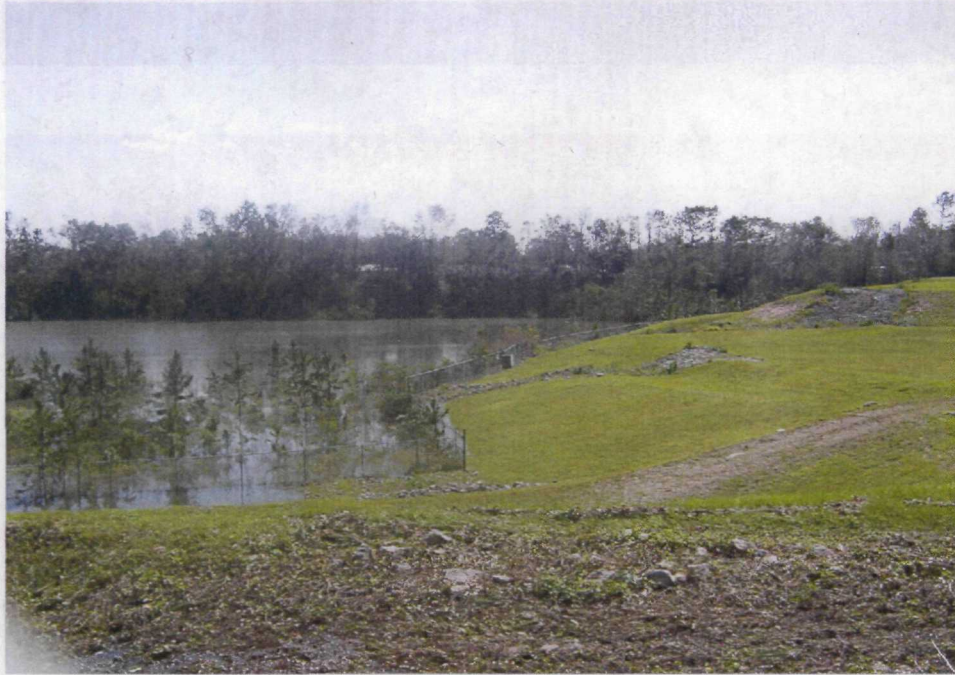
Photograph 18. View looking south from the perimeter fence on north side shows pond water level on September 17, 2004, one day after Hurricane Ivan visited. The water has receded about a foot.

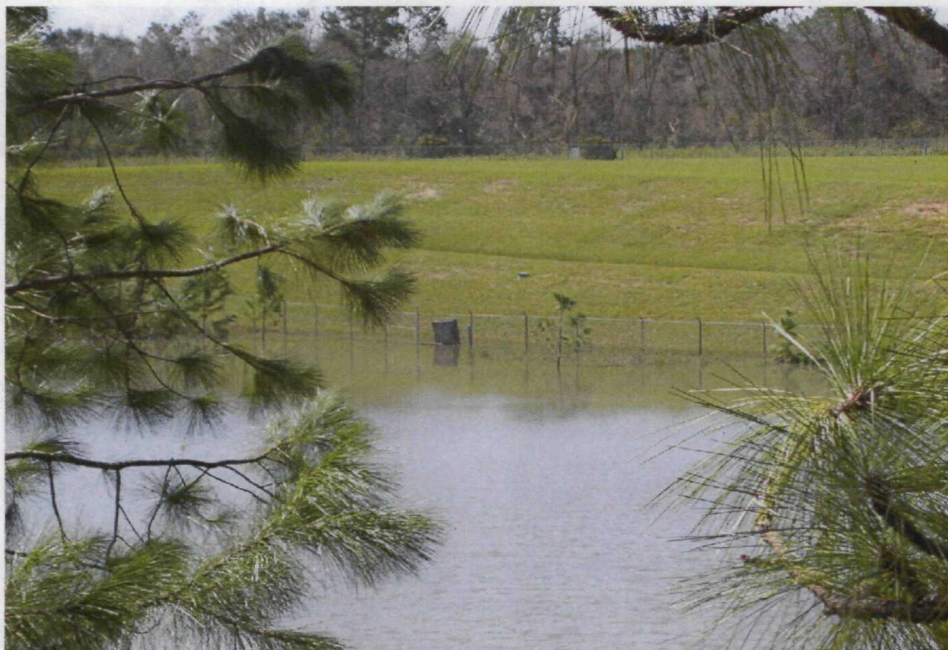
Photograph 19. View looking west from the east side of the perimeter fence shows pond water level on September 17, 2004, one day after Hurricane Ivan visited. The water has receded about a foot but is still within the landfill cap area and has flooded wells MW-17 and MW-18.
